Biedermann M, Karst I, Zinke O, Bontadina F, Schorcht W. 2021. Rare lesser horseshoe bat *Rhinolophus hipposideros* as traffic casualty after the opening of a motorway. ScienceMatters, 22 March 2021. doi:10.13140/RG.2.2.26079.74407

Rare lesser horseshoe bat *Rhinolophus hipposideros* as traffic casualty after the opening of a motorway

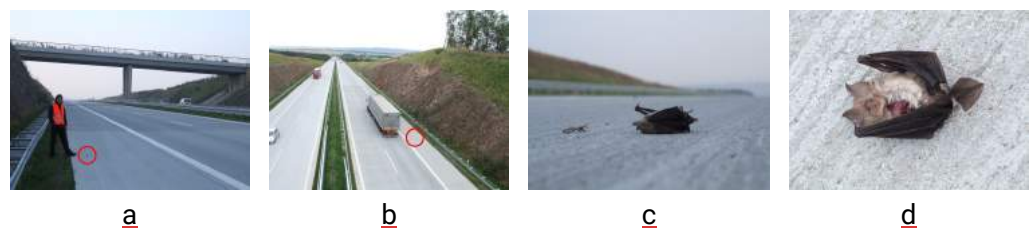
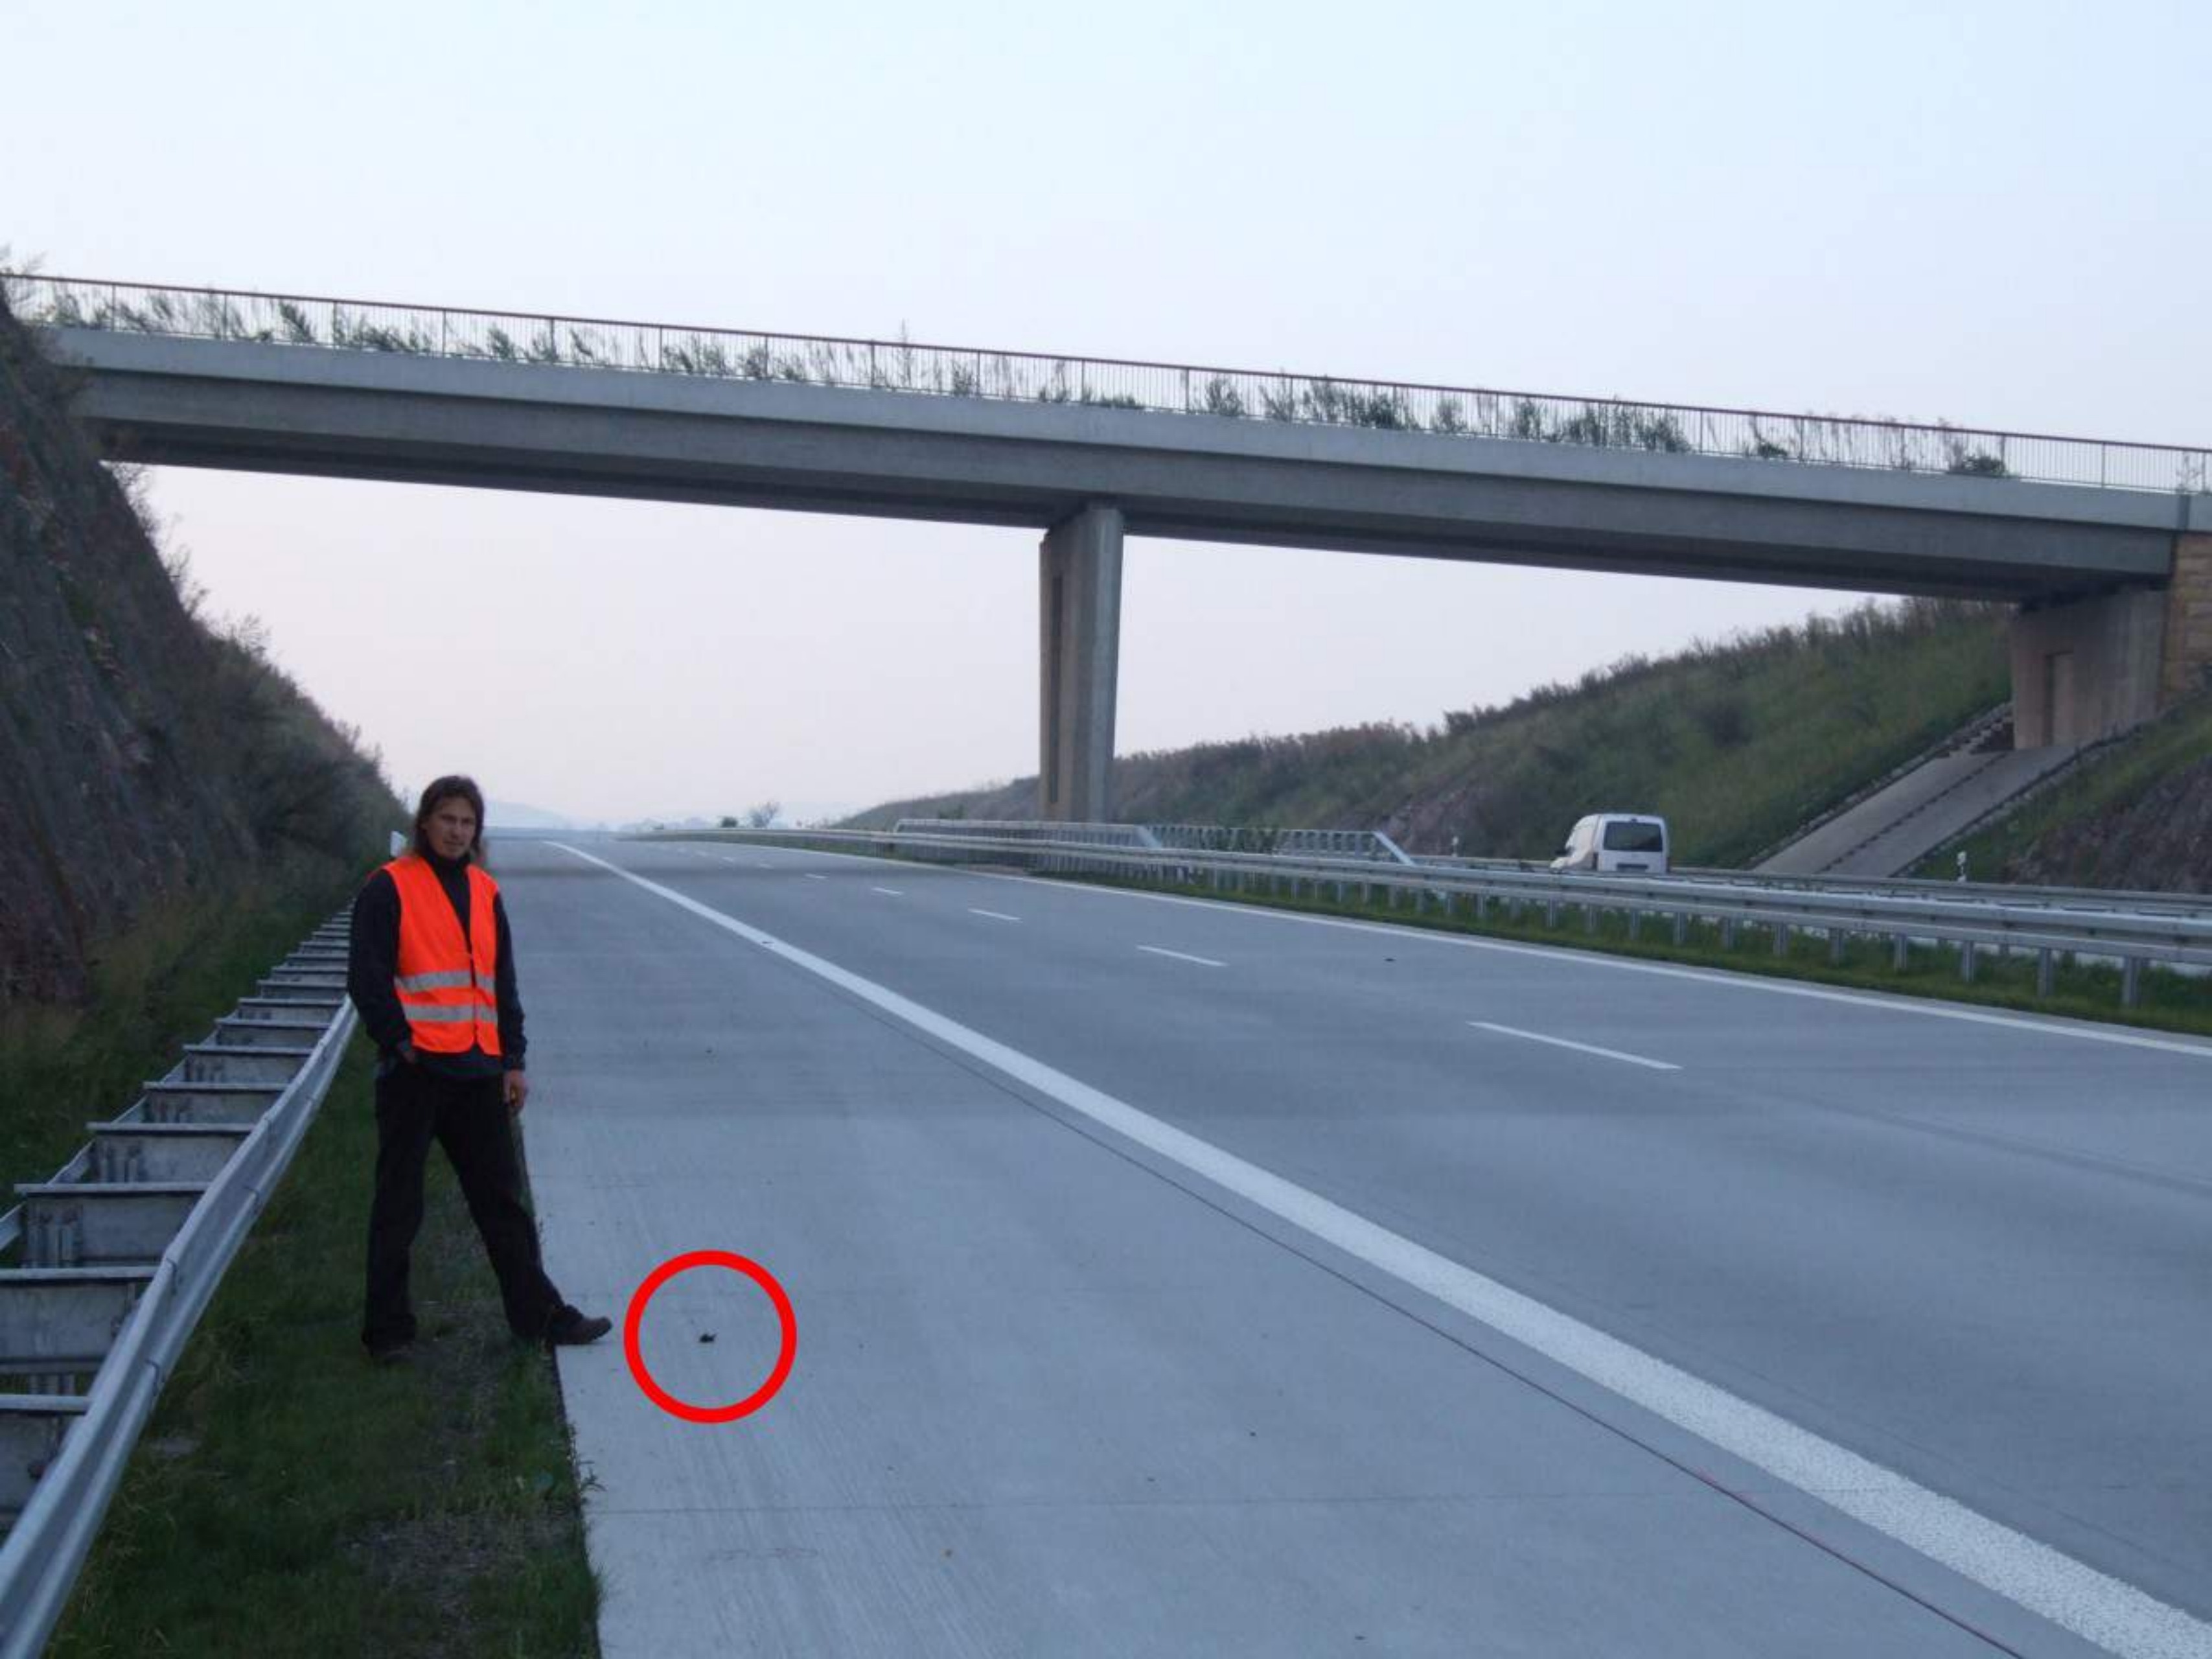
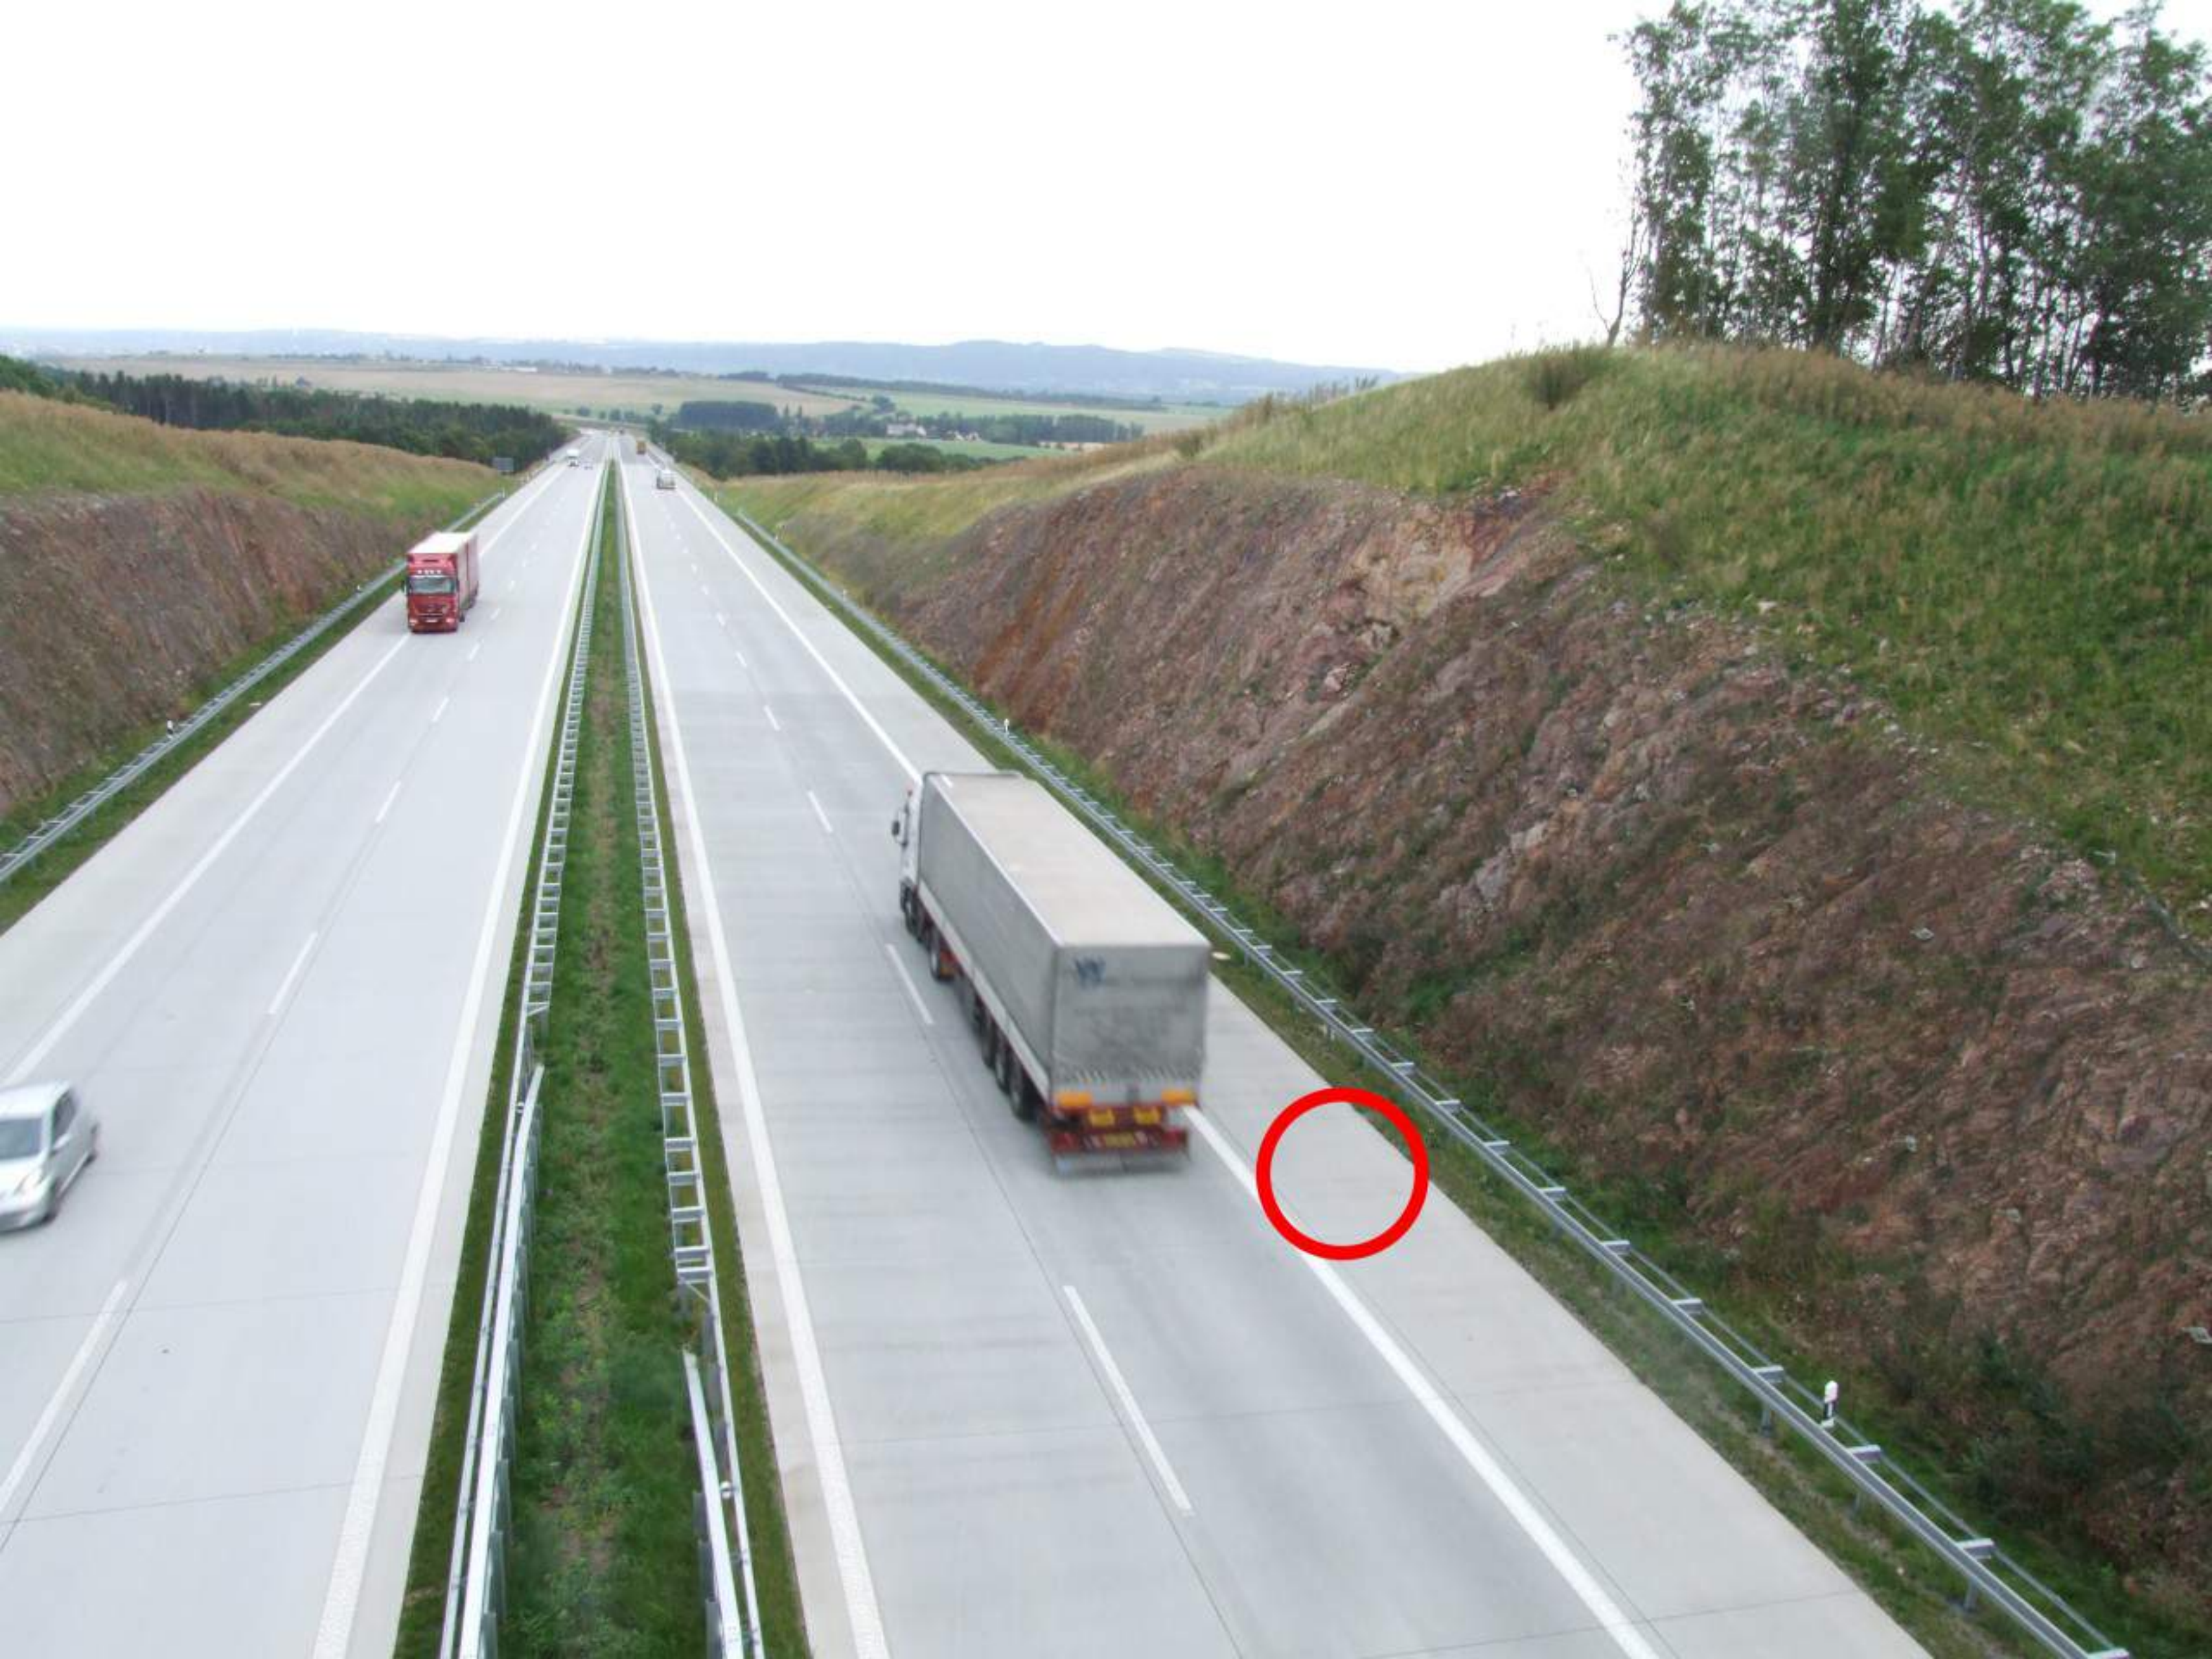
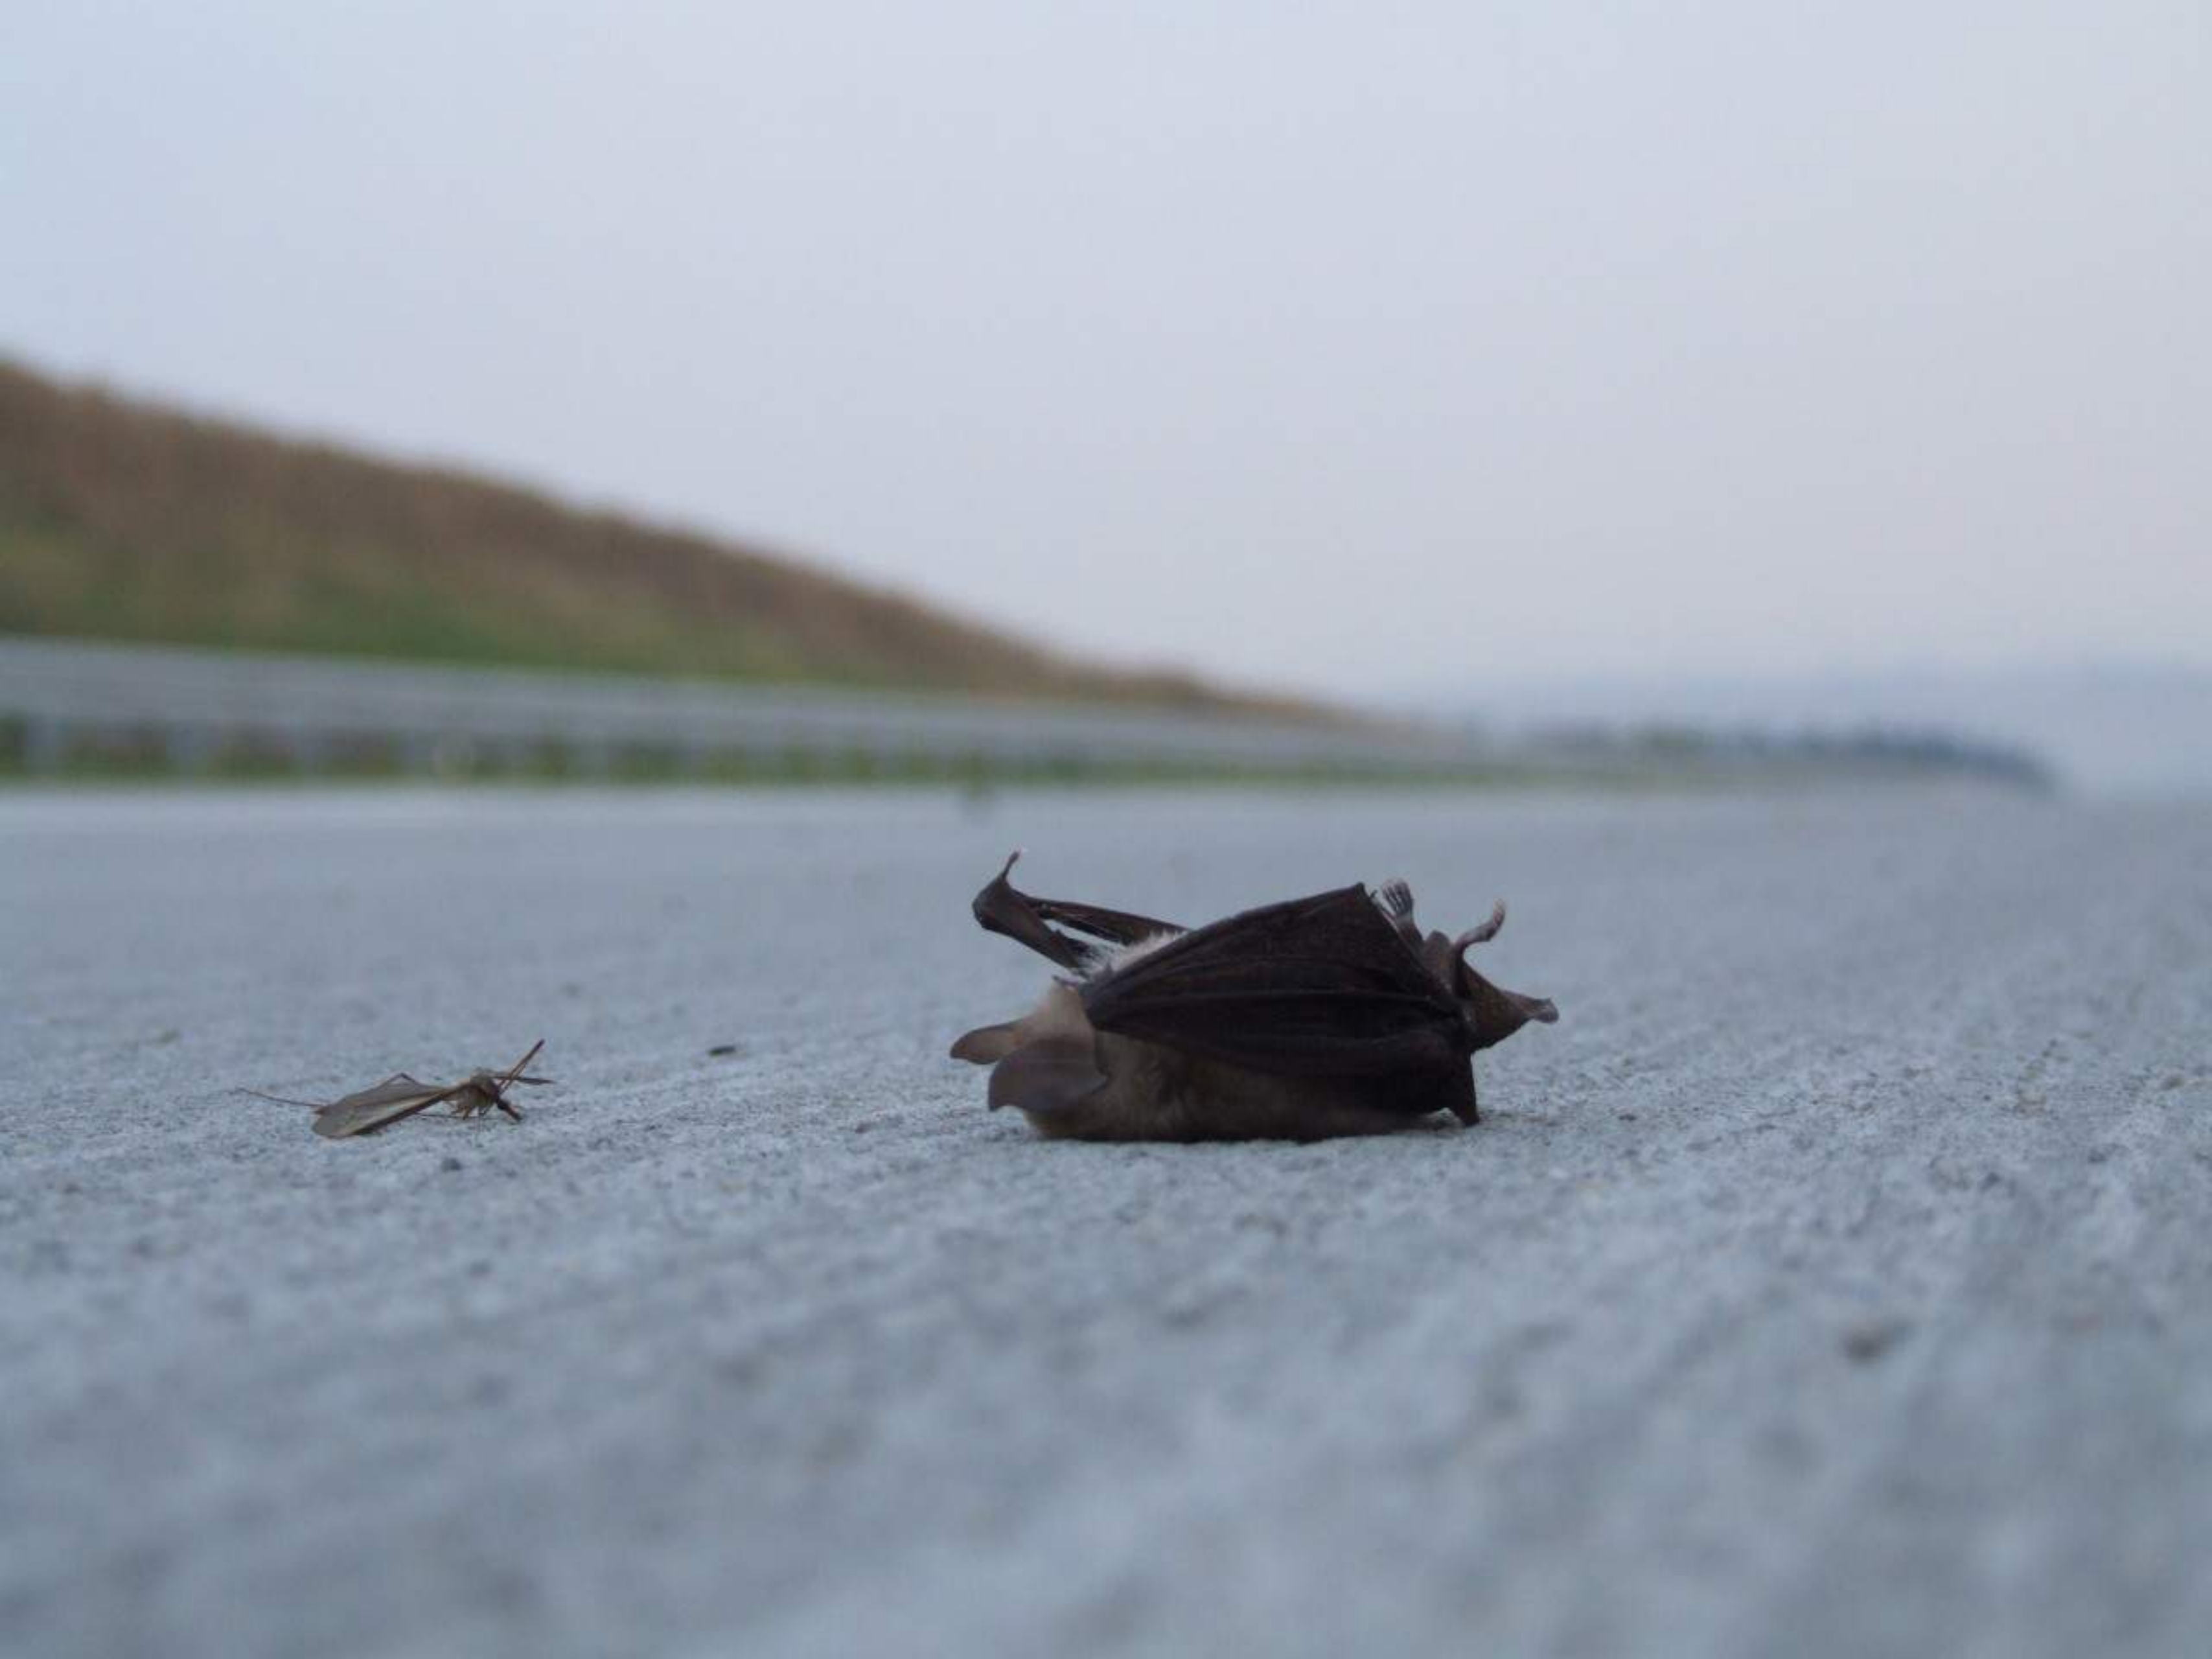
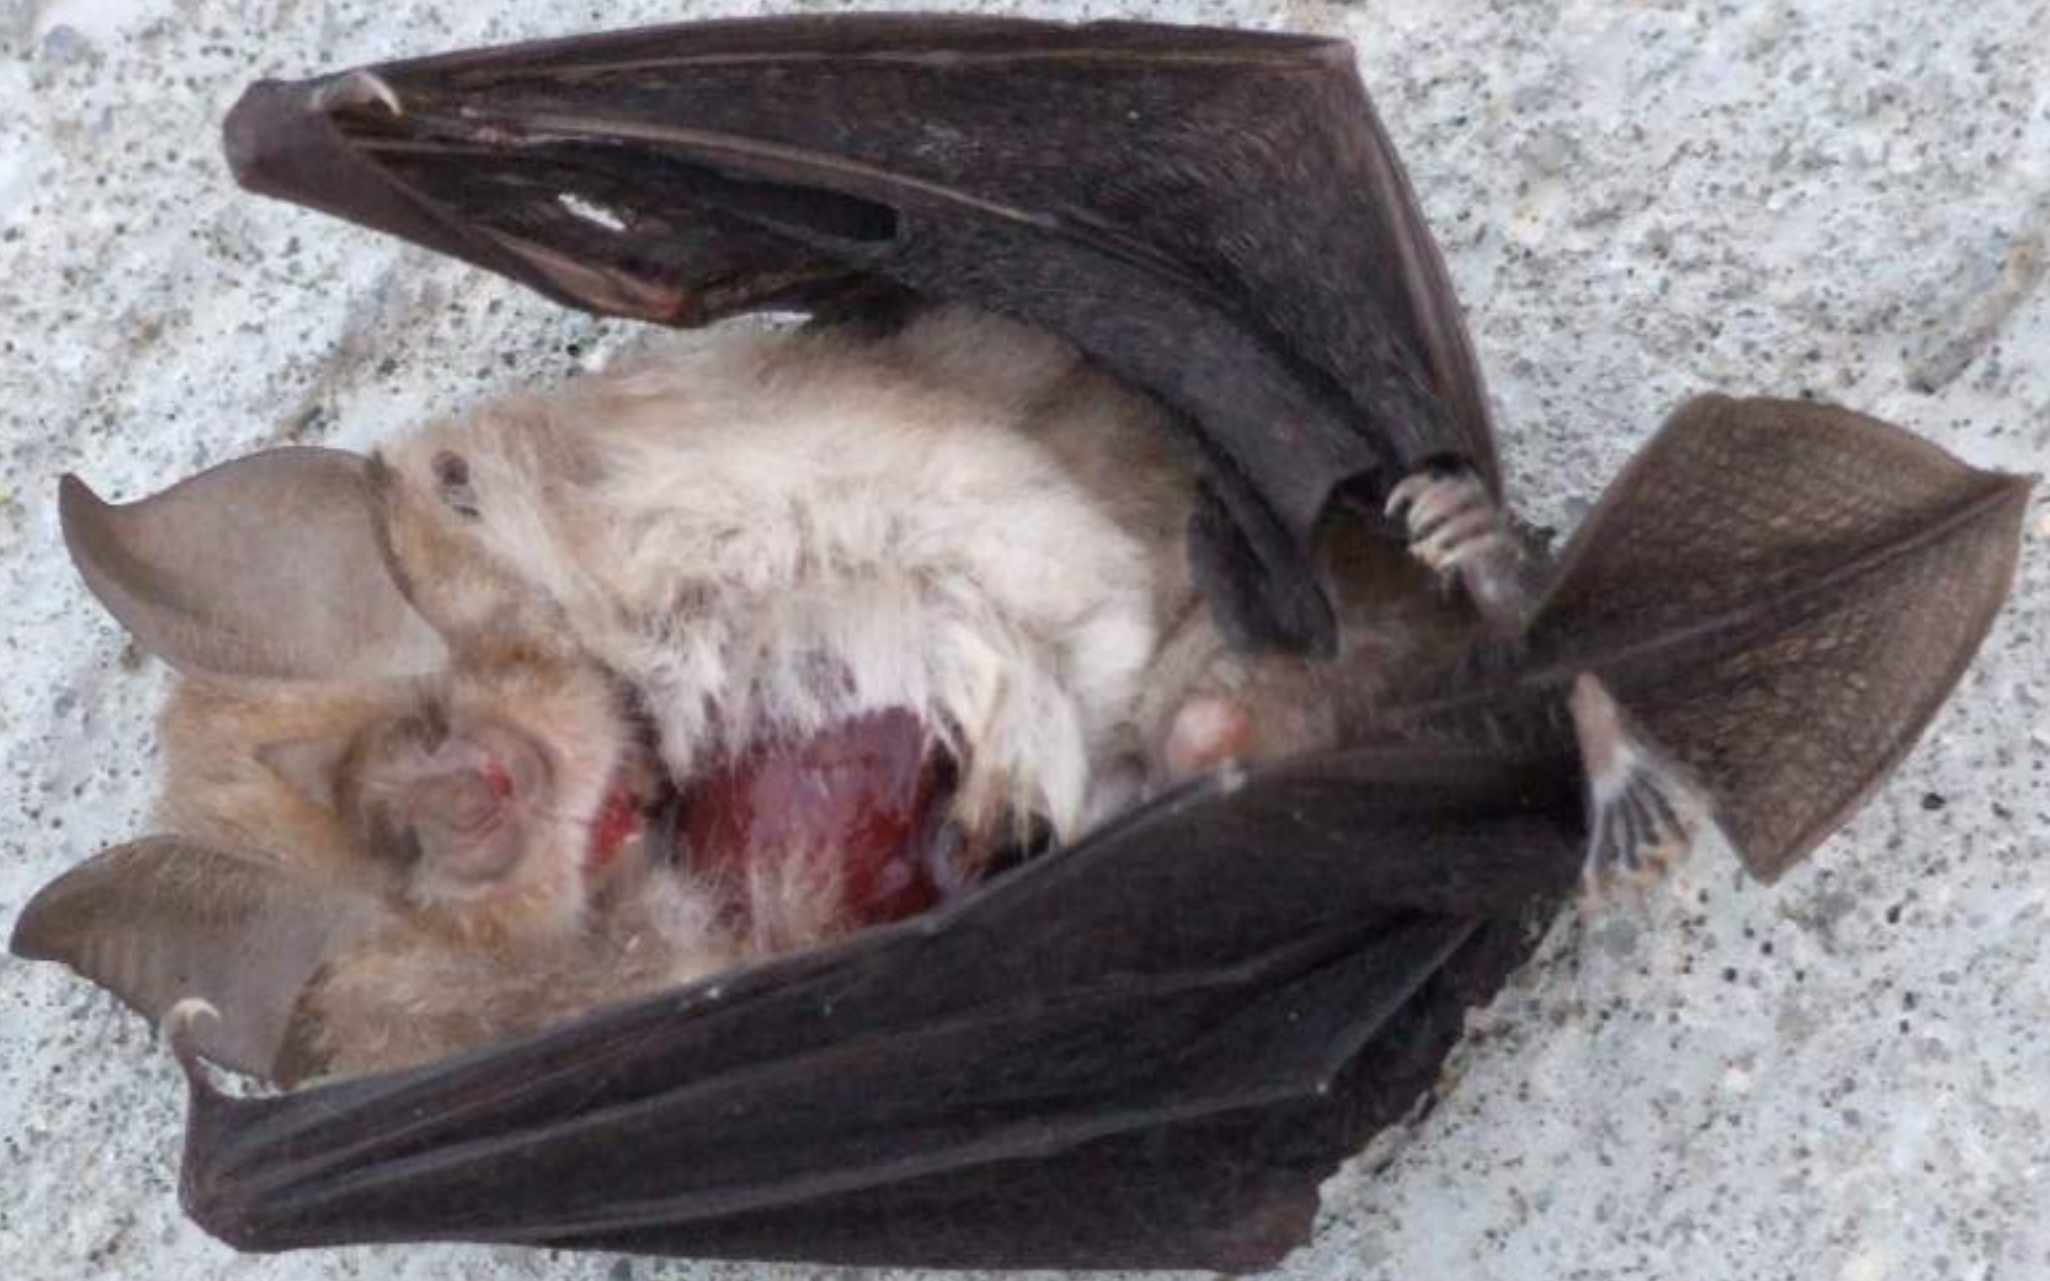
Figure

Location and situation (red circle) in which the bat was found on the emergency lane shortly after the opening of the new motorway.

a) Location near a hedge bridge (in the background), constructed for bats to safely cross the motorway. The site of the accident is near a former flight corridor (revealed by radio-tracking prior to the road construction).

b) Motorway cuts into rocky terrain.

c) Dead lesser horseshoe bat, early morning of August 26th, 2007, on the emergency lane, next to it a crane fly (fam. *Tipulidae*), typical prey for this bat species.

d) Dead specimen with injuries visible in the abdominal wall.

development of a hematoma, skin of the left wing ruptured extensively, rupture of the abdominal wall on the right side with organs partially visible outside of the abdominal cavity, extensive tearing of the skin ventrally from chest to chin, diaphragm rupture, pericardial rupture and lung ruptures on both sides (*Fig. 1d*). Damages indicate the collision with a vehicle.

At the time of our study, the nearby crossing structure - a hedge bridge designed for bats (*Fig. 1a*) - was not yet fully functional. This was also one of the results of the acoustical monitoring within the framework of the monitoring of the hedge bridge's effectiveness. We assume that the limited or even missing functionality was mainly due to the lack of developed vegetation on the bridge functioning as guiding structure. Shrubs along the bridge had been planted the previous year only and were still small. The high number of casualties in other animal groups reveals the deficit in protective measures for these taxa and the limited potential to restrict the number of victims.

Based on the results of the monitoring in the first year (see the multi-step monitoring program: ^[11]), glare protection and protective fences were retrofitted to improve the acceptance of this bridge as flight corridor. The effectiveness of this type of hedge bridge could be confirmed in the course of the 10-year monitoring program (^[11]).
