**Final Report** 15 May 2015

# **Investigation of the effectiveness of bat and bird detection of the DTBat and DTBird systems at Calandawind turbine**

3MW Wind Turbine  
Calandawind AG  
Feldstrasse 17  
7023 Haldenstein  
[www.calandawind.ch](http://www.calandawind.ch)

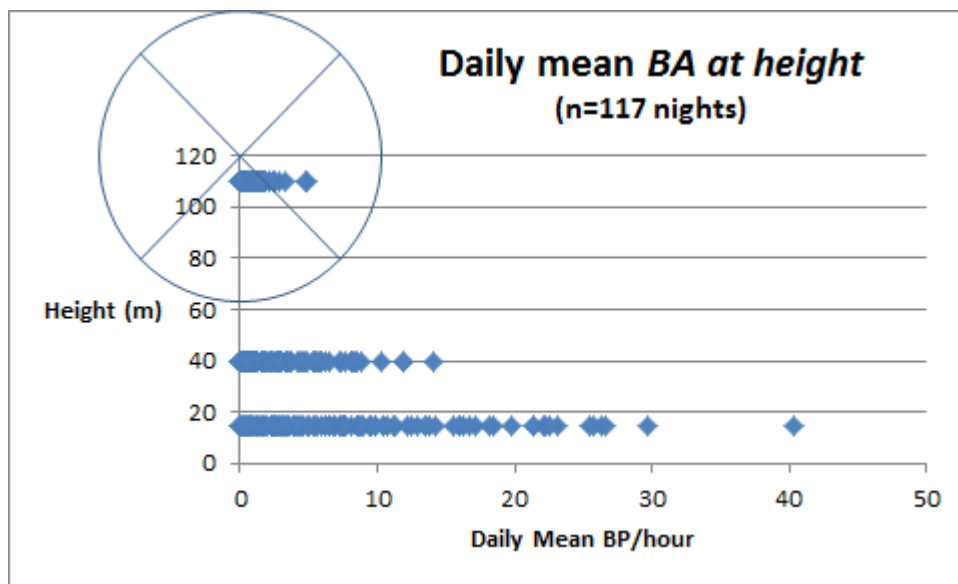
**Figure 2. Mean values of *BA* registered daily (n=117 night) at the 3 heights monitored in the WTG Calanda (01/07/2014 to 31/10/2014). In the Y axis, *BA* has been centered 10 m above the location of every *Bat detector* located in the tower, and 10 m below the *Bat detector* located in the nacelle.**
